DETECTION AND MONITORING OF NAPHTHENIC ACID CORROSION IN A VISBREAKER UNIT USING HYDROGEN FLUX MEASUREMENTS

J.M. O'Kane and T. F. Rudd Chevron Limited Pembroke Plant Pembrokeshire SA71 5SJ Wales, UK

ABSTRACT

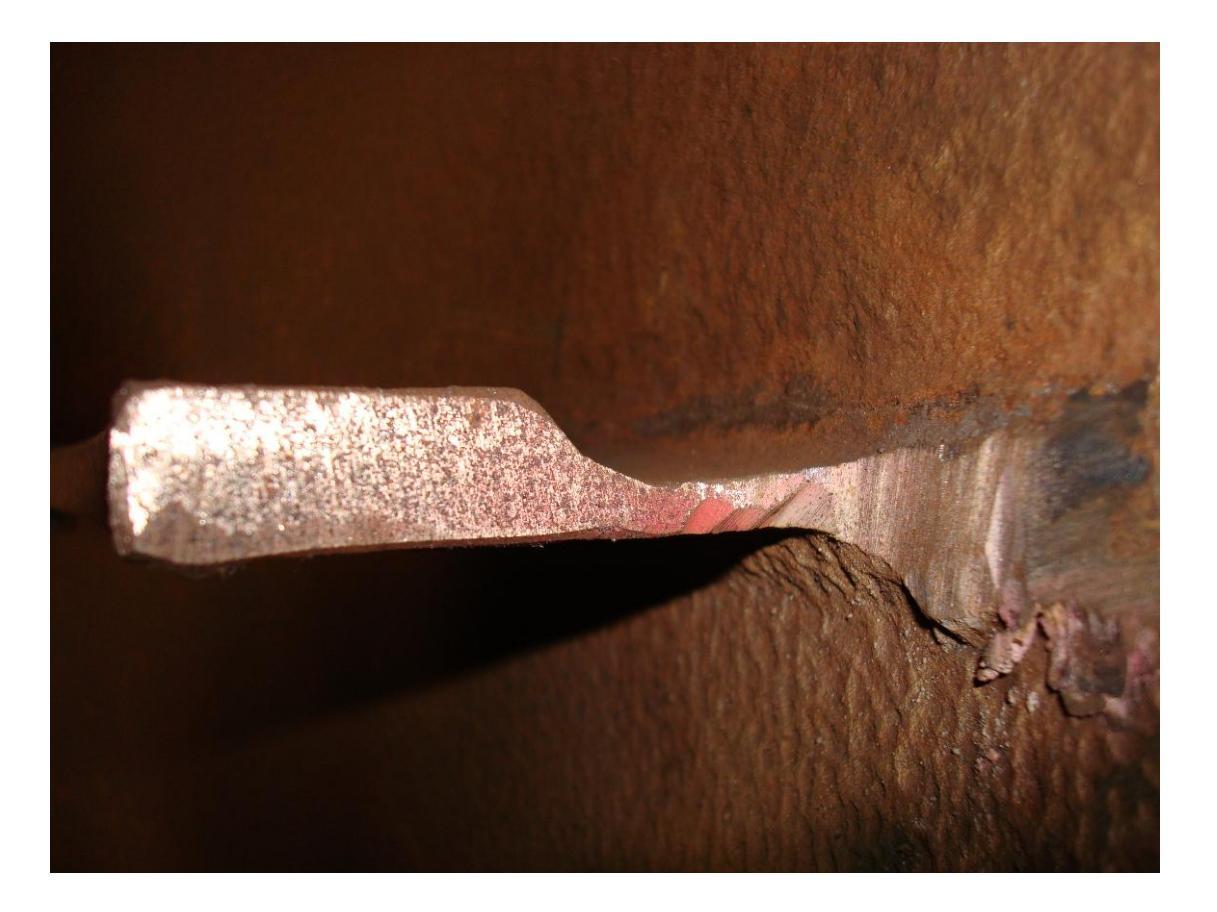
Corrosion of the Visbreaker fractionation column was initially brought to light in April 2008 when a small, localized fire occurred due to a pin-hole leak on the East side in a downcomer below tray 12 (tray 16 being the uppermost). Smooth, uniform corrosion in highly localized areas was found within the downcomers from trays 10 to 14. Corrosion losses of up to 10.5 mm were also apparent at the circumference of the carbon steel support rings adjacent to the shell at tray 8 (see Figure 1) and at trays 10 to 14. Lesser levels of corrosion were seen in trays 9, 15 and 16. The corrosion was localized to areas of liquid flow, with a pattern that suggested it was related to fluid flow conditions.

The same corrosion deposit sample analysis detected several organic acids, but primarily hexanoic acid ($C_5H_{11}COOH$). The boiling point of hexanoic acid (202°C) corresponds well with the temperature in the area of highest corrosion. Tray 12 operating at 200 °C was the most severely corroded of all the trays, with trays 10 -14 experiencing corrosion to a lesser degree.

FIGURE 1: Tray 8 support ring corrosion

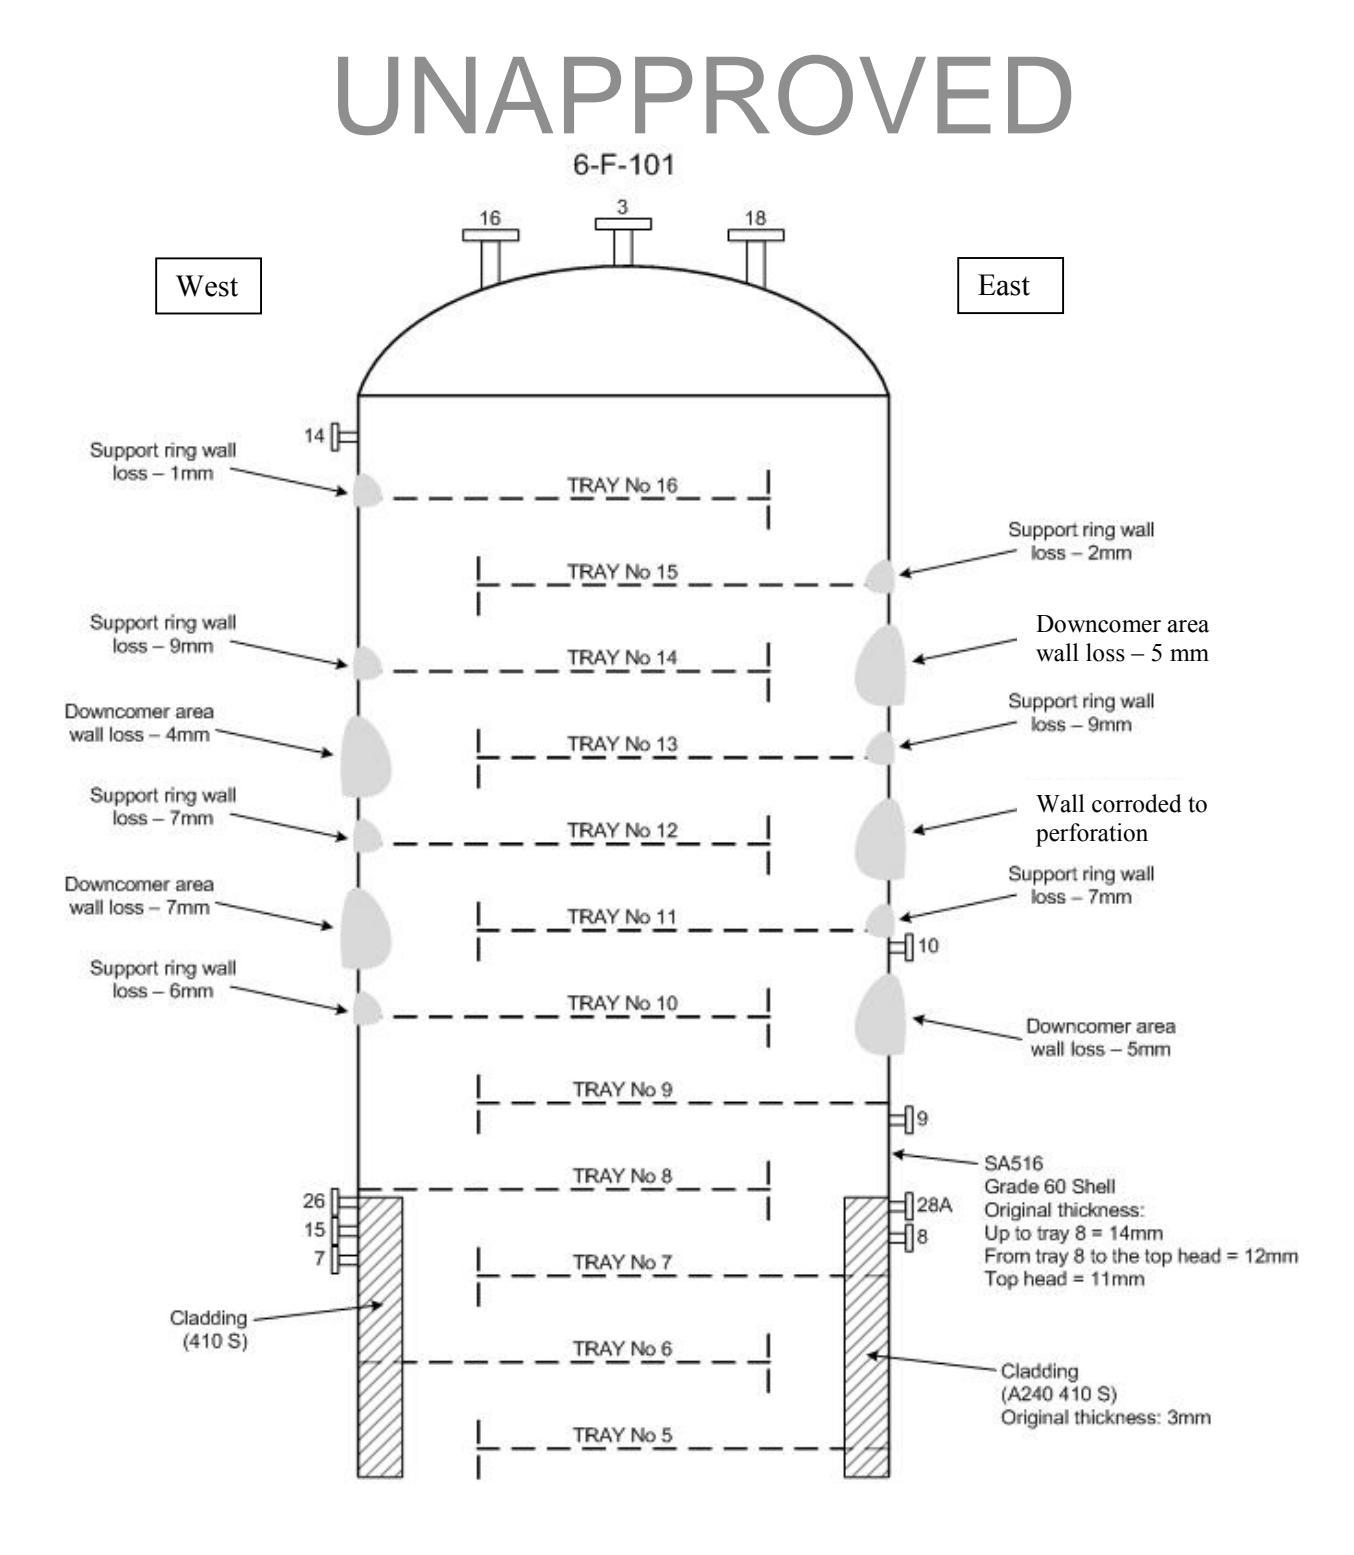
The internal layout of the upper portion of the column and the corrosion in this area is detailed in Figure 2. The operating temperature at trays 10-14 where the corrosion was most severe ranged from about 180 to 220°C (~200°C at the perforation at tray 12). Also, the East side of the column was more corroded than the West side (see corrosion rates in Table 1).

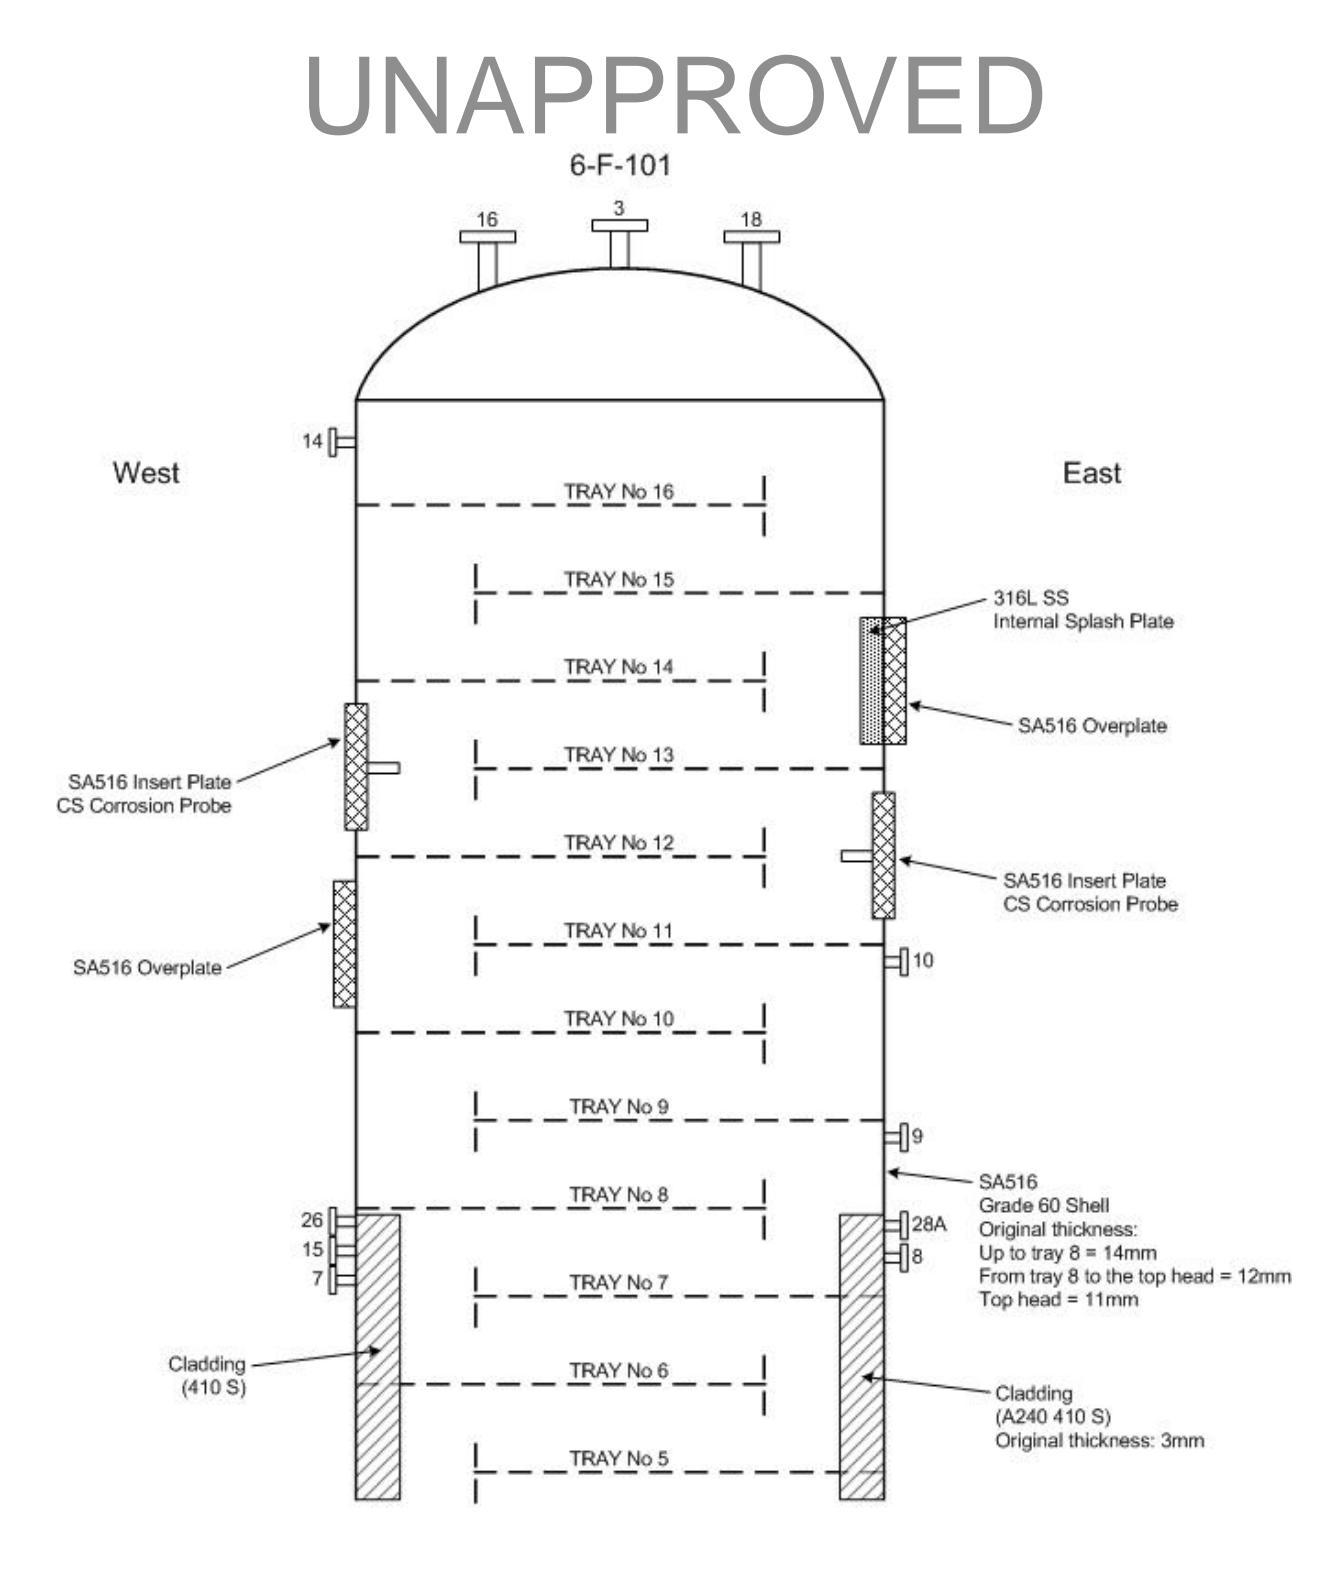
FIGURE 3: Location of insert plates, over plates (lap patches), splash plates and corrosion probes fitted to the column.

Figure 3 details the repairs that were made during shutdowns in June 2008 and in February 2009. During the June 2008 shutdown, shell insert plates were installed near trays 12 and 13, and lap patches were installed in the area of trays 11 to 14. A tubular style carbon steel electric resistance probe was installed on the West side in the downcomer between trays 12/13, and a 5Cr probe was installed on the East side in the downcomer between trays 11/12.

In December 2008 nine months after the initial failure, a scheduled on-stream ultrasonic thickness monitoring (USTM) scan revealed corrosion rates of up to 0.8 mm/month (Table 1), so it was apparent that further repairs would be necessary. A filming amine was injected into the column via the top reflux starting in January 16th 2009 to minimize further metal loss. The repairs were performed in February 2009, including a monitored hydrogen bakeout prior to welding. Further external over-plates were installed over thinned areas of the shell, and 316L stainless steel 'splash plates' were fitted to the inside of the column in the downcomer area between trays 13 and 14 to try to prevent corrosive fluids impinging on the thinned shell sections.

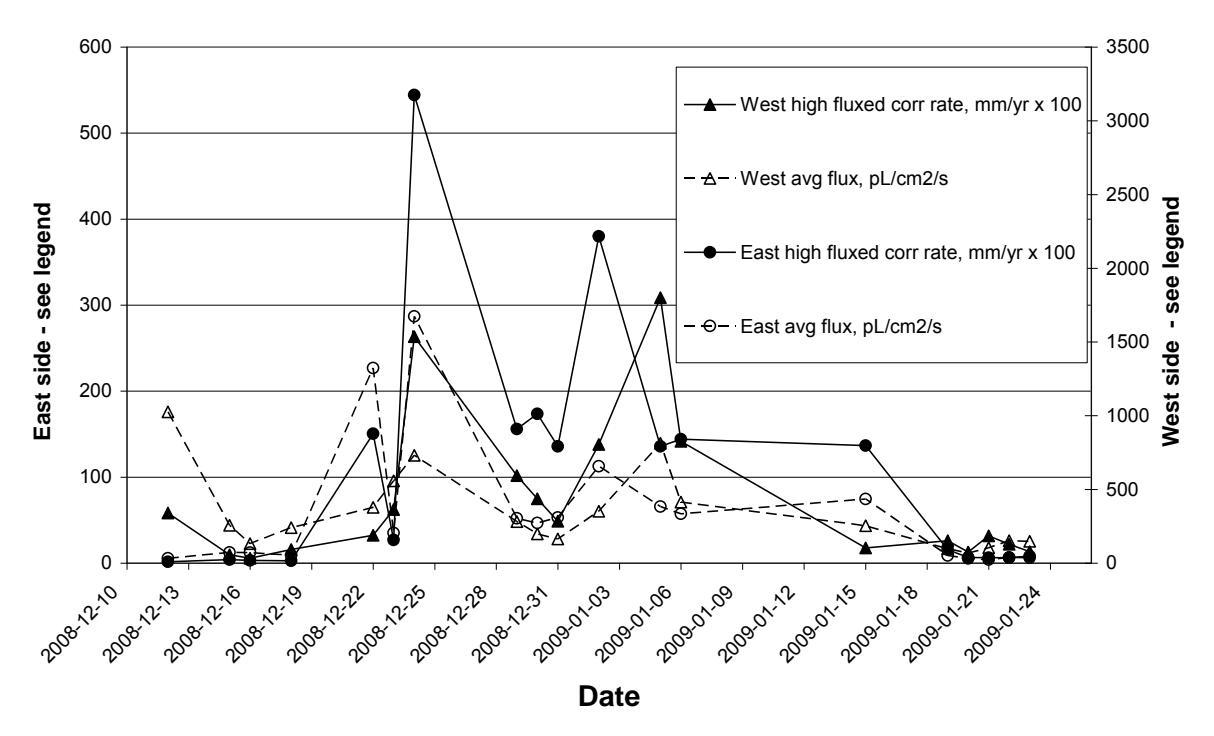
In Figure 4 all recorded flux data is presented for the West and East side of the fractionator. The collation of flux from different sites is reasonable, and though the East and West side data sets show broadly the same corrosion episode, there is some difference in detail. Moreover, the flux on the East side is about 10 times higher. This is believed to be due in part to asymmetry within the fractionator, and in part due to a cooling by moisture laden westerly winds from the cooling towers to the west, to which the uninsulated fractionator was very exposed.

Hydrogen permeation through steel is very temperature dependent. For a 200 °C process temperature, a 20 km/hr direct wind is expected to decrease the surface temperature by 20 °C, the average wall temperature by about 10 °C, and hydrogen permeability by about 17 % according to (3), whereby the corrosion rate may be underestimated by the same amount. A further decrease in flux of some 15-30% is expected from the 'stripping' of measured flux collected from sites on the exposed West side, as discussed in detail elsewhere⁹. In short, these factors, as well as an underlying decrease in corrosion on the West side of the fractionator caused by exposure to high winds, may all have contributed to the observed decrease in flux on the West side.

FIGURE 4: All hydrogen flux site readings

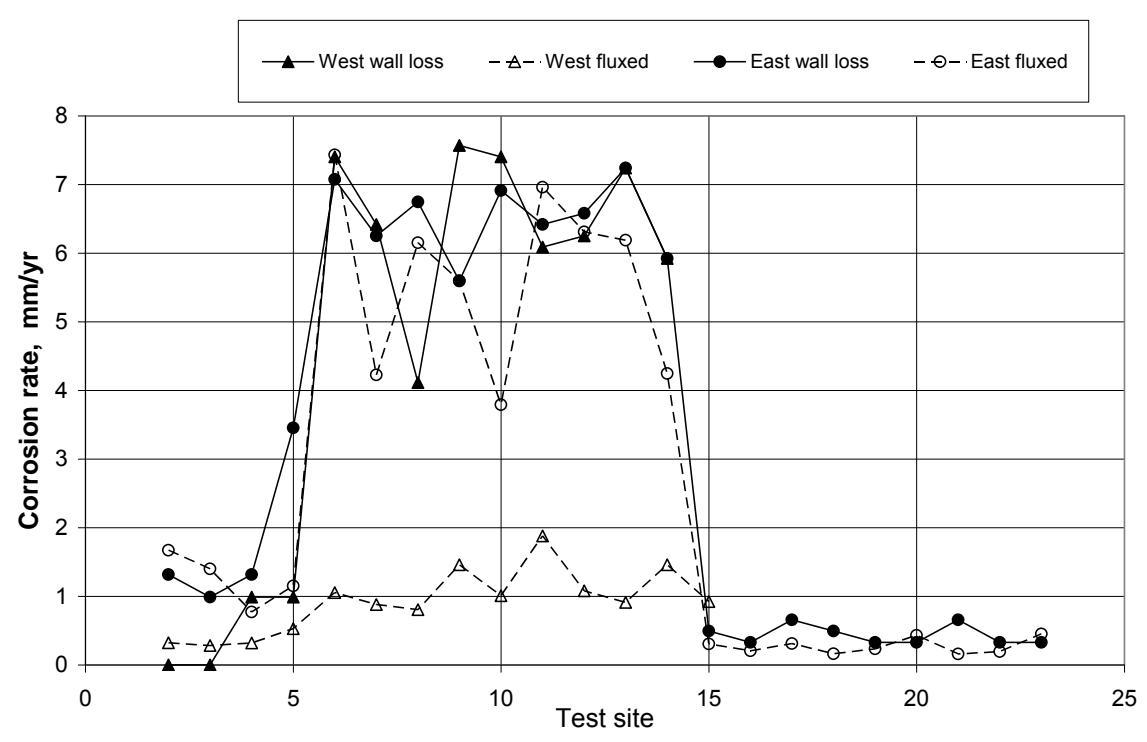
The estimated corrosion rates for each test site, derived from time weighted average flux-thickness data between the period December 12, 2008 and January 23, 2009, converted into corrosion rates according to equation (4), are presented in Figure 5, together with corrosion rates derived from UT data on 30 May 2008 and 7 January 2009. The agreement between the flux and UT thickness derived rates on the West side is remarkable, given that the time frames are so different. It might be concluded that corrosion had been very severe for the entire time frame of the UT measurements. It is also noticeable that high flux readings are exclusively registered at sites of high corrosion.

FIGURE 5: Comparison corrosion rate derived from hydrogen flux (50 days to 30 Jan 2009) to corrosion rate determined by ultrasonic thickness measurements (222 days to 10Jan 2009)

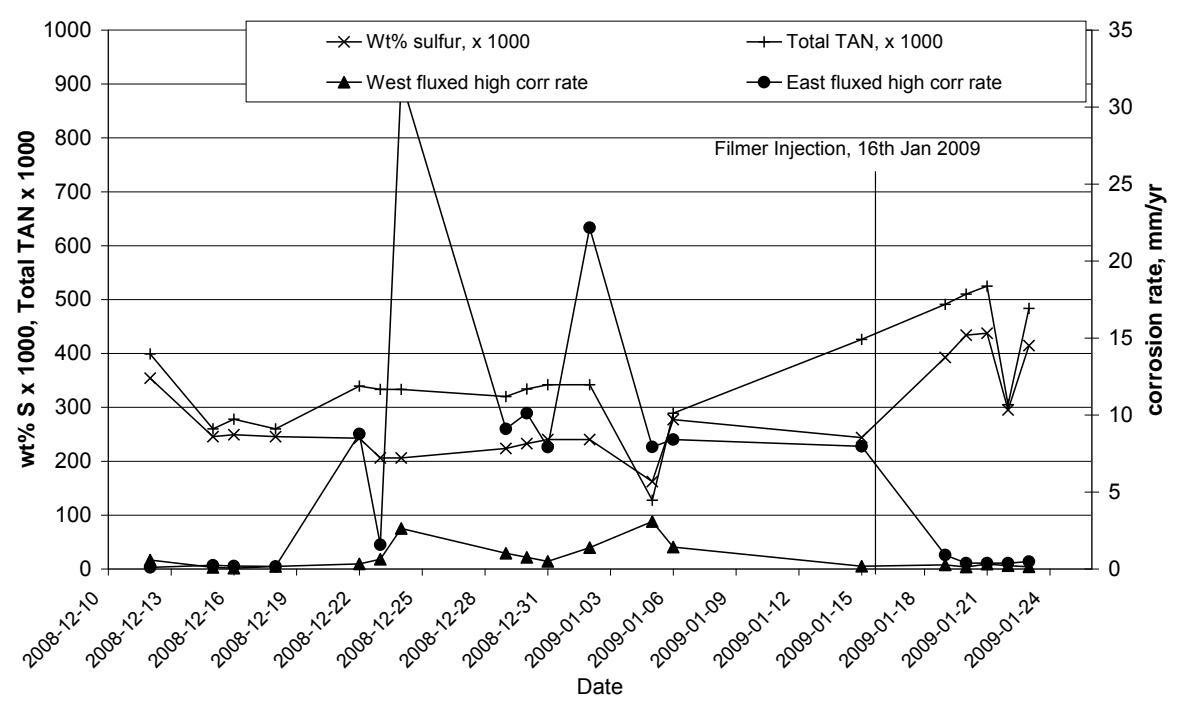
In Figure 6a and 6b, real time corrosion rates are estimated from average flux at all the sites of high corrosion, and plotted against various process variables, including whole crude S and whole crude TAN. There is no clear trending with any particular variable, except possibly one might say that the high flux excursions around 23 December 2008 coincided with a significant process upset, evinced by the variable temperature.

Figure 6a shows the effect of introducing the filmer into the fractionator column on the measured hydrogen flux readings. The filmer was introduced on the 16th January, and was expected to take up to 48 hours to become active. By the time of the next hydrogen flux measurement (19th January), hydrogen flux readings on both sides showed a significant decrease from their previous levels, dropping by almost a factor of ten on the East Side of the column. These low readings continued until the cessation of monitoring on 23rd January.

FIGURE 6a: Corrosion rate versus TAN and S. Note that TAN remains approximately level throughout the period, but that corrosion rate drops when filming inhibitor is introduced

Due to the corrosion rates evident in the column, it was decided in January 2009 to inject a corrosion inhibitor into the column via the naphtha reflux stream at the top of the column. The corrosion inhibitor chosen was a filming amine, designed to form a tightly-adherent protective film on the internal surface of the metal. The purpose of the film is to protect the underlying metal surface from attack by the corrosive species.

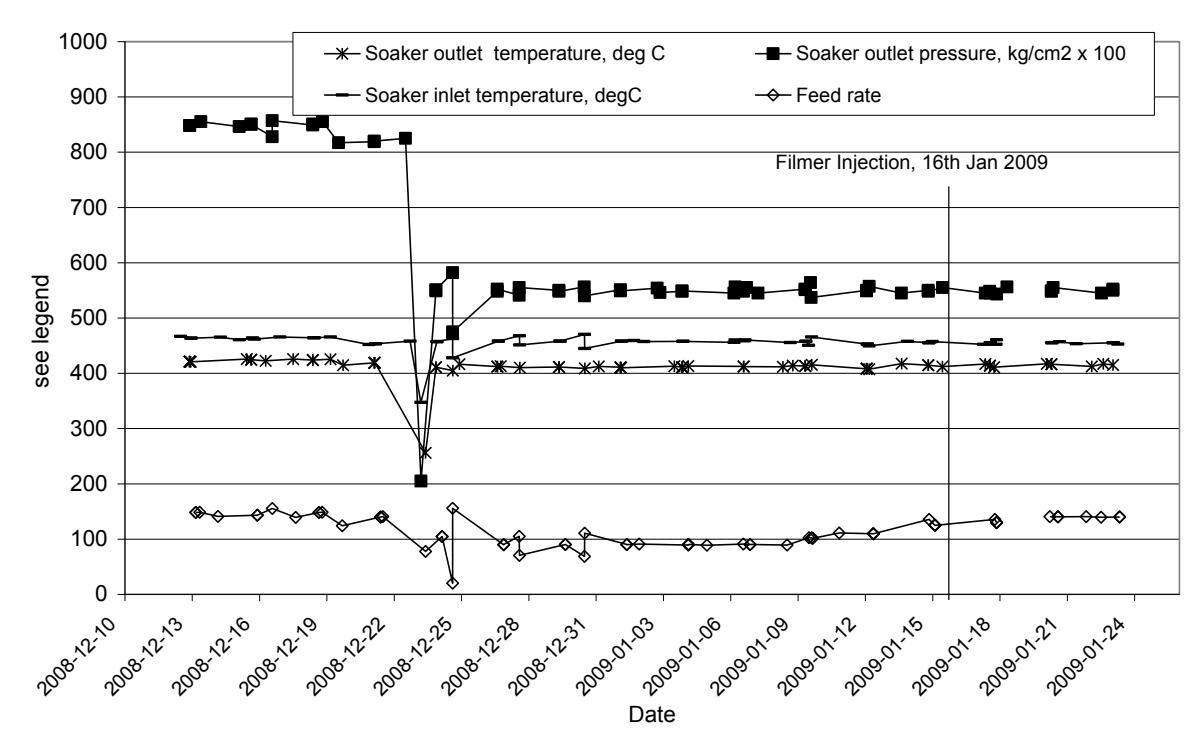
The feed rate to the column was monitored throughout this period, and was found to be increasing at the time the inhibitor was injected (see Figure 6b). Increased feed rate would increase the fluid flow and velocities within the column, and would tend to increase corrosion, so this can also be rejected as a possible explanation for any decrease in corrosion rate and hydrogen flux.

FIGURE 6b: Additional operating variables during the period of corrosion monitoring (compare corrosion rates in Figure 6a)
