Hydrogen Bakeout Monitoring

Superheat FGH, 13 November 2012

Cases of Monitored Bakeout Preventing Unscheduled Downtime

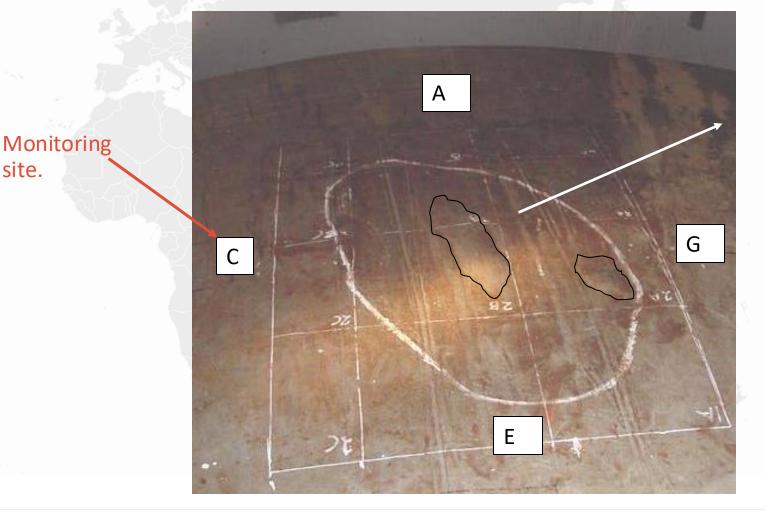
Vessel dome in HF service had sustained hydrogen damage. Areas of blistering are indicated

Arrow shows direction of recent lamination growth

site.

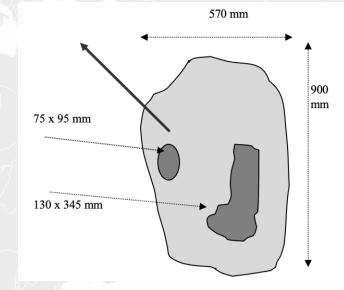
Sept. 1999

...as determined by TOFD and USTM.

450 mm 60 x 70 mm 70 x 150 mm Blisters Blisters

Steel 4cm thick, Damage was 7 – 15 mm from *external* face.

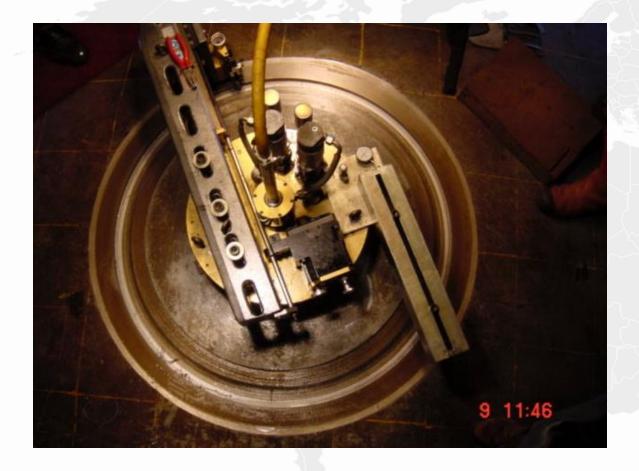
It was decided to remove the affected steel:

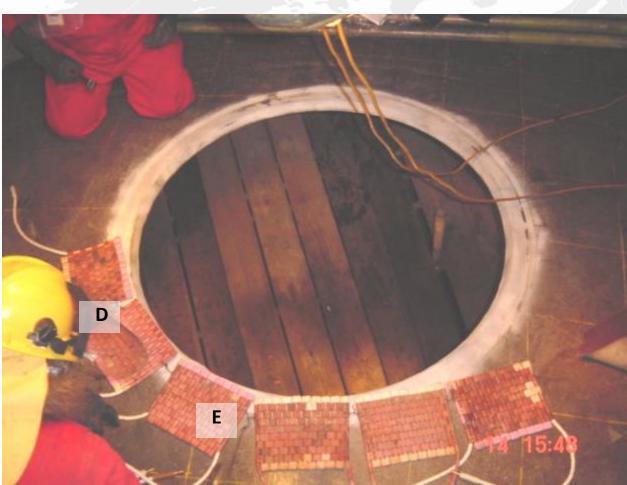
...set up heat treatment circuitry...

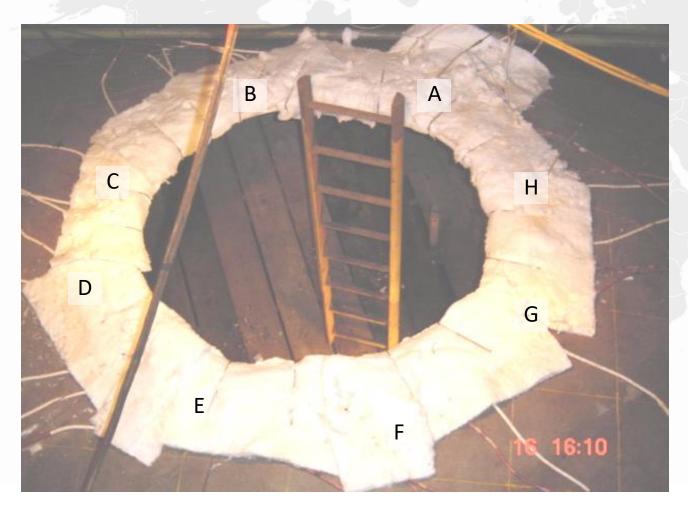
...bake out at 300 degrees Centigrade whilst monitoring hydrogen at circumferential sites, note 3 is normally sufficient ...

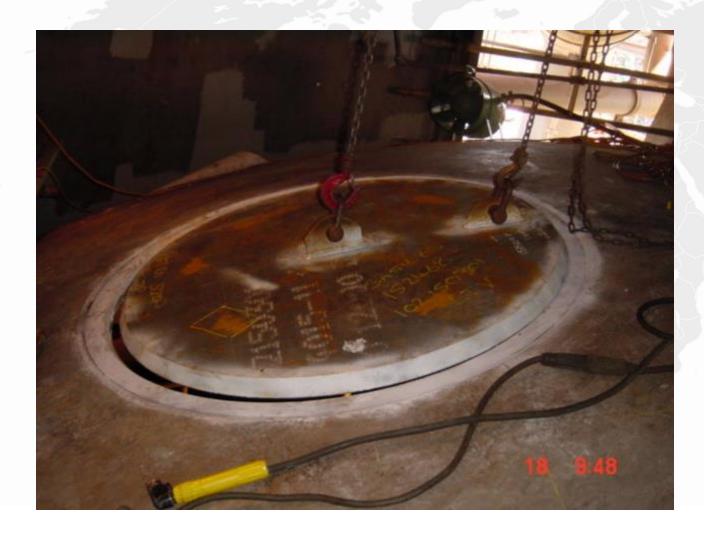
...and fit a new plate.

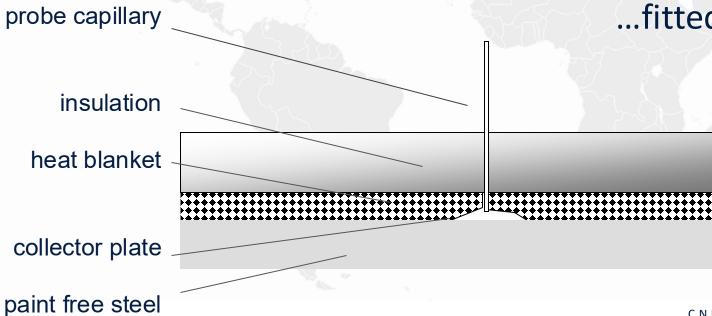
Hydrogen monitoring engaged the Hydrosteel[®] HT-R probe...

...fitted between adjoining heat pads...

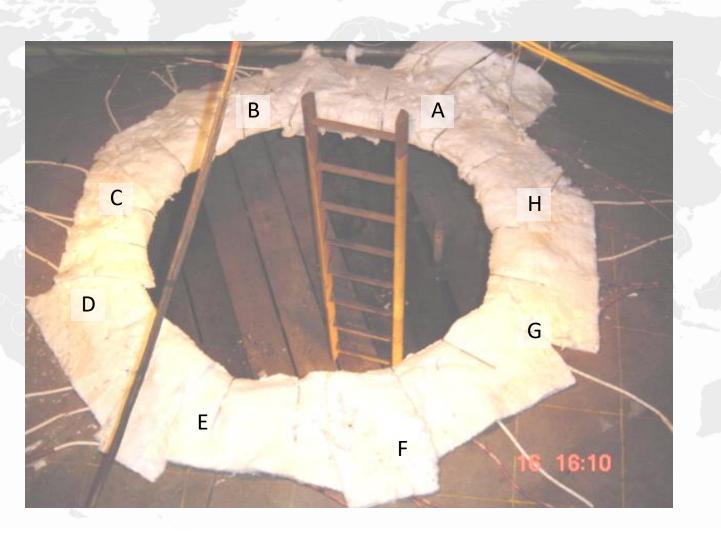
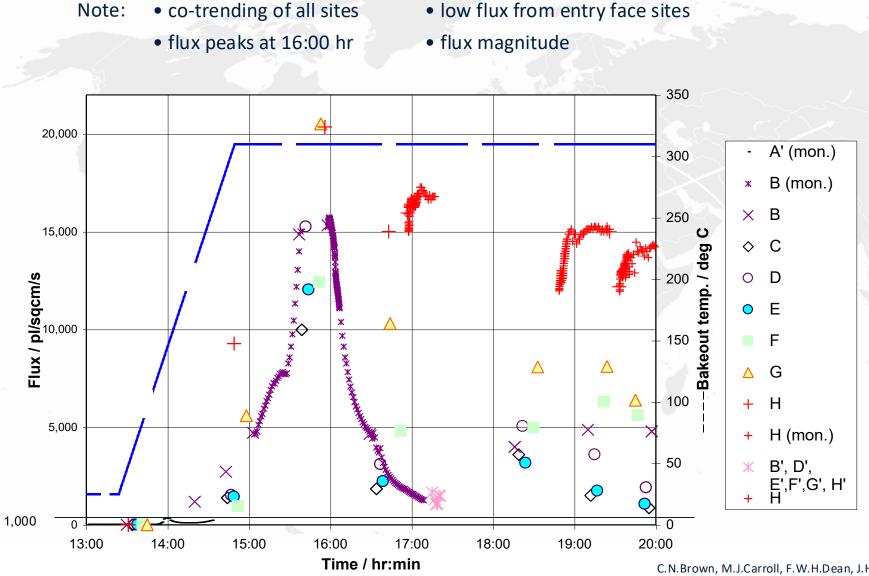
Monitoring Sites

Top of vessel in HF service: 8 circumferential locations

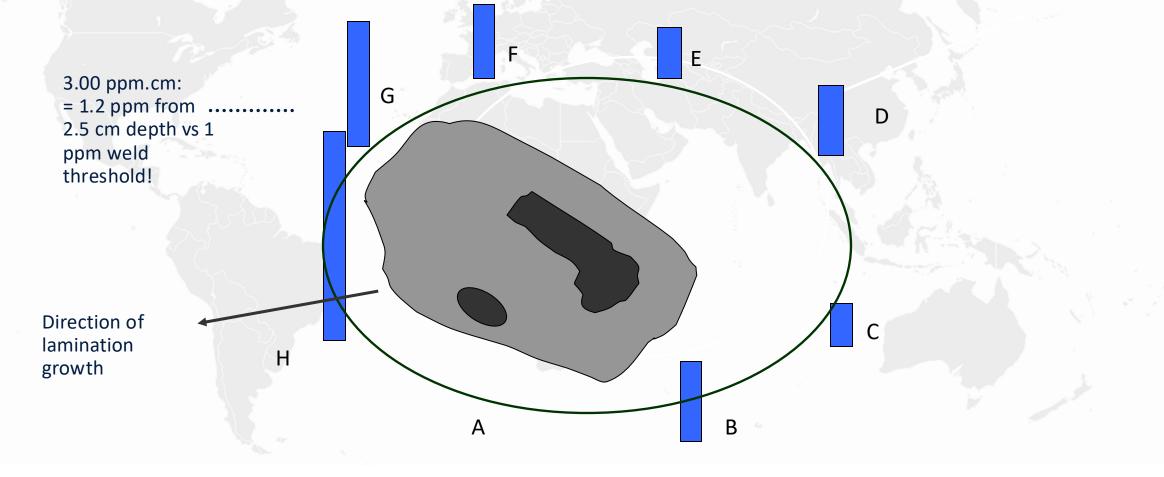
Correlation of bakeout monitoring data with historic damage

Outgassed concentrations obtained by summing area under each site flux profile: $eg 10,000 pl/cm^2/s$ for ~3 hr = 1 ppm.cm hydrogen in steel

Due to high flux, monitoring was continued for an additional 8 hours whereupon it fell below 1000 pL/cm²/s.

Refiner wrote into procedure discontinuance of bake out permissible after reaching peak temperature, on decreasing flux of <1000 pL/cm²/s.

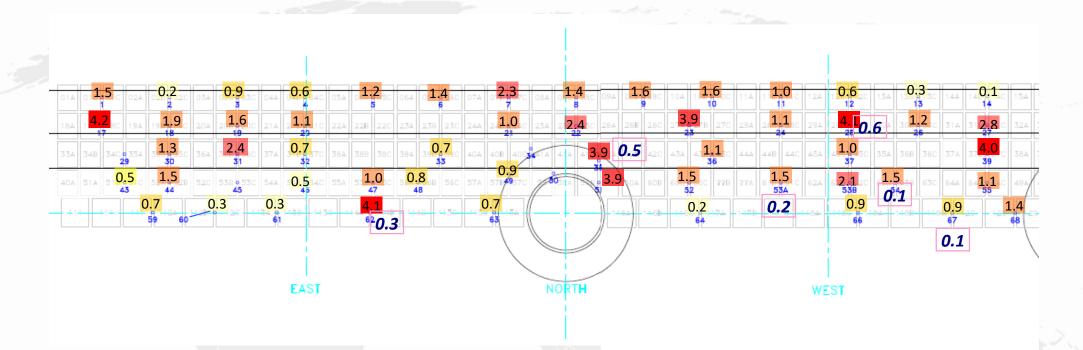
Major Installation Engaging 66 Probes

Total outgassed hydrogen in PPM colour coded. Numbers in italics indicate estimated remaining diffusible hydrogen in excess of 0.1 ppm at a few sites

Due to high flux, bakeout was correctly extended to 16 hours.

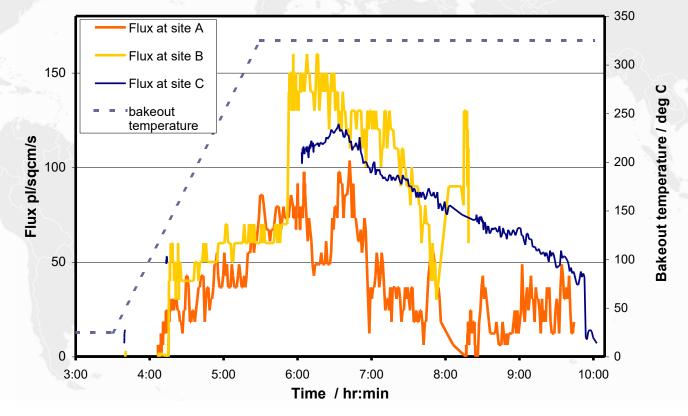
Pre-weld hydrogen bakeout monitoring on three equidistal, circumferential sites on a high-pressure hydrogen column section, 5cm thick. Service ~80°C

Turnaround on column potentially foreshortened by 4 hours.

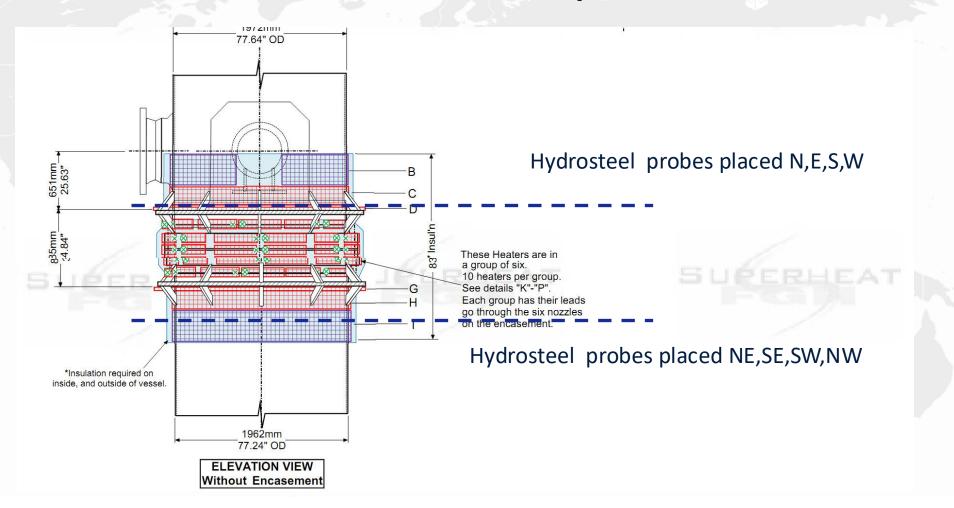
Texas tower encasement repairs - PWHT

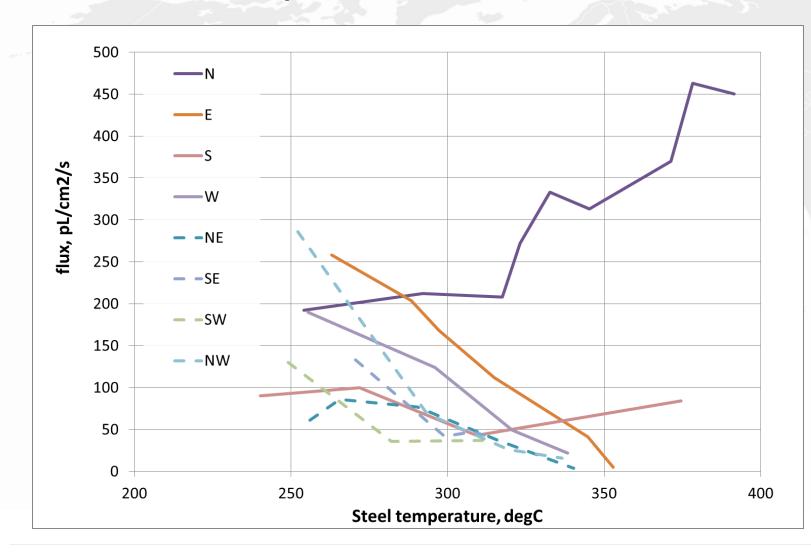
Flux versus temperature

Turnaround on tower, behind schedule, foreshortened by 6 hours.
