# Hydrogen-induced cracking and blistering

Hydrogen damage to steel is a well-known consequence of corrosion in sour service. A corrosion inhibitor program can reduce hydrogen entry into the metal. This decreases or eliminates hydrogen damage, resulting in higher profitability and plant availability

Berthold Otzisk and Agnoulia Gourzoulidou *Kurita Europe*

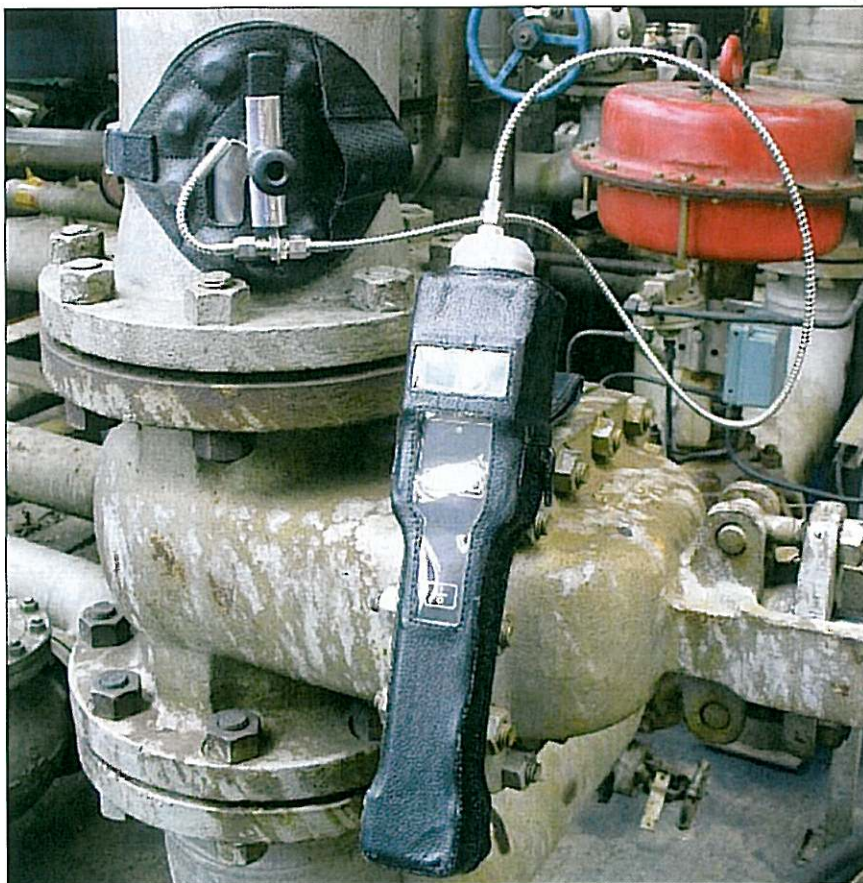
Figure 3 Flux measurement

A number of flux measurement technologies have been developed over the years. The technique used in this work has been described as the hydrogen collection method,<sup>12</sup> embodied within a commercial tool, the Hydrosteel 6000 from Ion Science in the UK. The apparatus, depicted in Figure 3, gives reliable hydrogen flux spot readings within minutes of magnetic attachment of a hydrogen collector to a target steel surface. When so engaged, a pump in

the handheld instrument causes a flow  $F$  of ambient air to be drawn across the effective area  $A$  of contact between the collector and test surface into a central capillary through a conduit connecting the collector to the instrument, and across a proprietary amperometric hydrogen sensor within the instrument, where the increase in hydrogen concentration in the air  $c$  is registered and converted into a flux according to  $J = Fc/A$ .<sup>12</sup> The commercial tool provides flux resolution to  $1 \text{ pL/cm}^2/\text{s}$ .

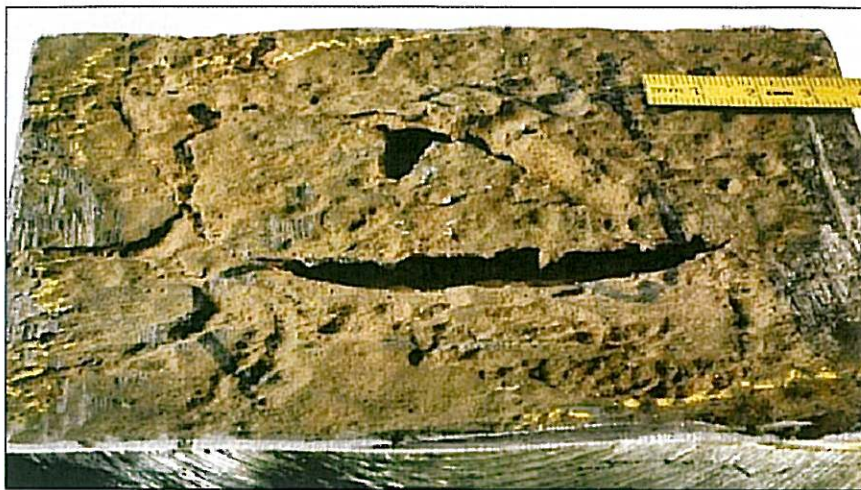
Figure 4 Cliffy notches and holes on the surface

- At the cut surface, the metal was cracked parallel to the metal surface
- The metal surface “partially” contained bulges (bubbles)
- Many work pieces showed cliffy notches (Figure 4)
- Some work pieces showed holes, which had a cavity below the interior surface
- Some work pieces showed a considerable decrease in the metal thickness.
