#### APPLICATIONS OF HYDROGEN FLUX MONITORING TO PRE-WELD BAKEOUTS OF STEEL

#### ABSTRACT

During a pre-weld bakeout, hydrogen efflux was monitored in real time using the hydrogen collection method at high temperatures. A circular section of a 50 mm thickness alkylation unit acid storage vessel dome which had developed severe hydrogen blistering was removed, and pre-weld bake-out applied using heat pads placed within twelve inches of the cut-away section perimeter, on the dome's exterior face. A ring of eight hydrogen collection probes were placed under the heat pads, about six inches from the cut-away perimeter. One probe became blocked and failed to deliver measurement. The remaining seven delivered flux values indicating effective bake-out at five sites, and the need for extended bake-out at two neighbouring sites. The efflux trend at these sites strongly indicated initially high concentrations of hydrogen liberated by the bake-out. Corresponding efflux measurements at corresponding positions on the dome's interior face were much lower. A model of hydrogen diffusion for the bake-out, incorporating a high density of trapping sites located at depths of 5-15 mm beneath the monitor

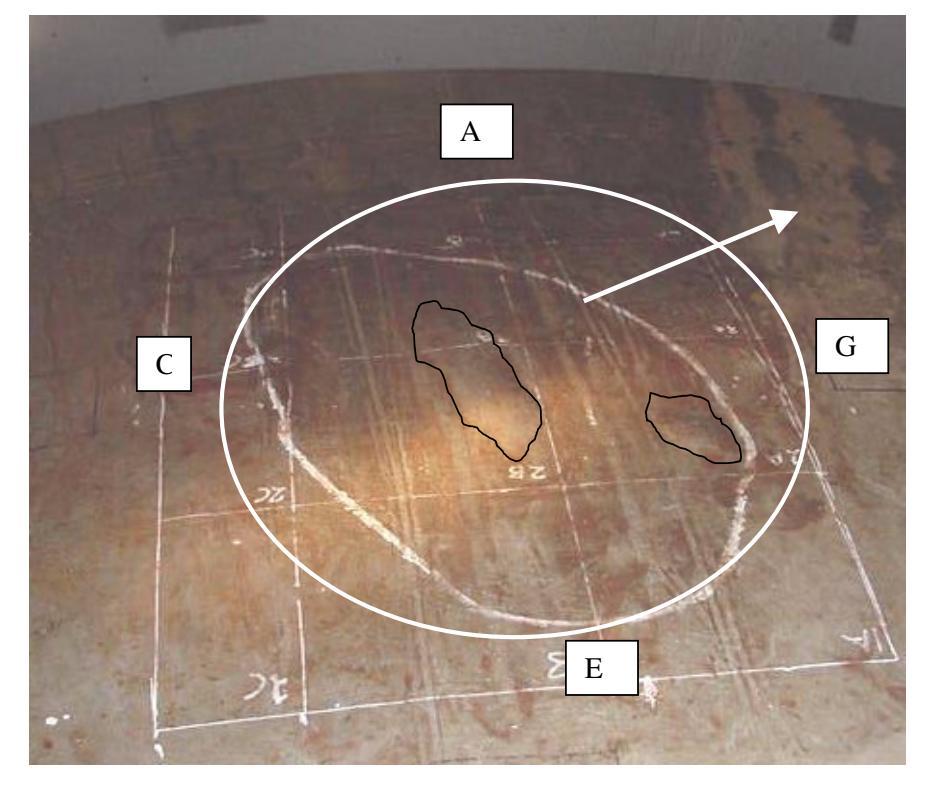
**Figure 1.** Photograph showing top of dome, lamination and blister zones, and boundary of cut-away section. The ellipse shows the approximate cut-away perimeter. Some bakeout probe locations are indicated with letters. The arrow indicates the direction of lamination growth prior to removal from active service, also shown in **Figures 2b** and **8**.

## small segregations and inclusions. Two hydrogen blisters were visible in the centre of the laminated area of plate, as shown in **Figure 1**.

A circular cutaway was removed as demarcated in **Figure 1**, and illustrated in **Figure 3**. The bakeout zone was located within twelve inches of the 1.2 m diameter cut-away section perimeter, as shown in **Figure 3b** on the dome's external face <sup>(1)</sup>. Initially thermocouple wires were attached to the vessel as shown. Heat-pads were located at the indicated positions, together with eight flux collection probes, as discussed below.

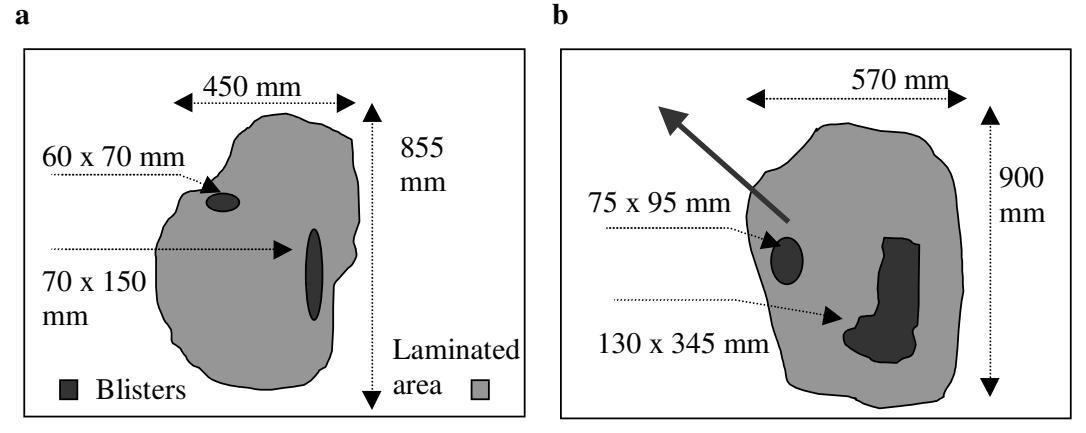
**Figure 2.** Blister and lamination growth as determined by USTM at 0 ° between **a**, Sept, 1999 and **b**, Dec 2000. The arrow indicates the direction of lamination growth prior to removal from active service.

Laminations that are parallel to the plate surface are not detrimental, unless they are in a hydrogen charging environment and are in close proximity to structural discontinuities, such as a weld. In this case, migration of diffusible hydrogen to the laminated area, and formation of molecular hydrogen at inclusions had caused the blisters to form and grow, as monitored by 100% manual ultrasonic test method (USTM) supported by time of flight diffraction (TOFD). Detailed corrosion mapping was also carried out to give a pictorial, two-dimensional view of the region<sup>1</sup>. It was further deemed necessary to carry out TOFD/USTM inspection on the interior surface of the top head to establish the true condition of the material below the blisters. In this case the blisters had, unusually, formed only 5 to 15 mm from the outer surface of the 50 mm thick plate, suggesting the material below was relatively defect free. The relatively thin ligament of material above the blisters enabled them to grow at a much higher rate than would normally be expected, as indicated in **Figure 2**.

Twelve months after the blisters were identified, flux was monitored at sites on, and bordering, the blister field shown in **Figure 2**. Spot flux values can be related to the entry hydrogen activity  $a_o$  (bar<sup>1/2</sup>) according to equation (2), derived in reference 3,

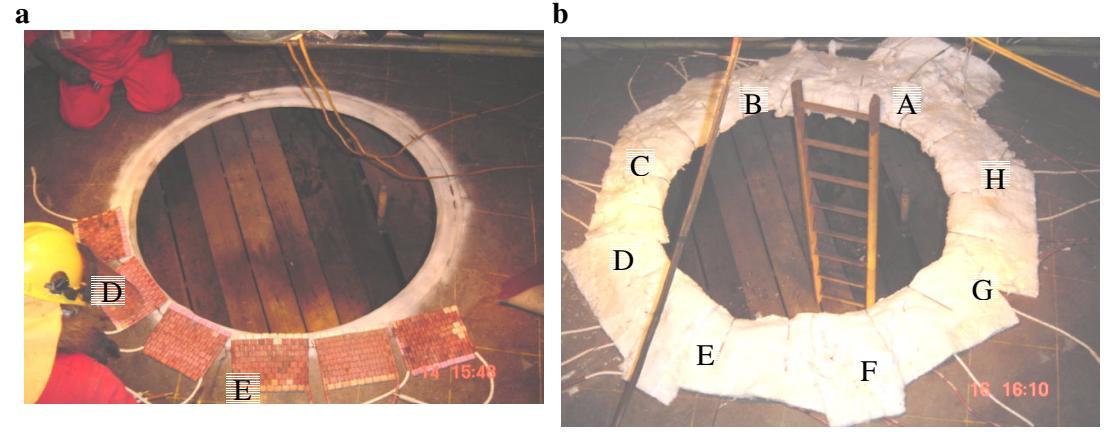
**Figure 3**. **a**, photograph taken shortly before installation of probes between alternate heat-pads as indicated for two probe sites D and E. **b**, complete heat treatment apparatus showing position of probes. The probe A capillary is connected to just visible gas sample conduit leading out of the picture to the hydrogen flux analyser.

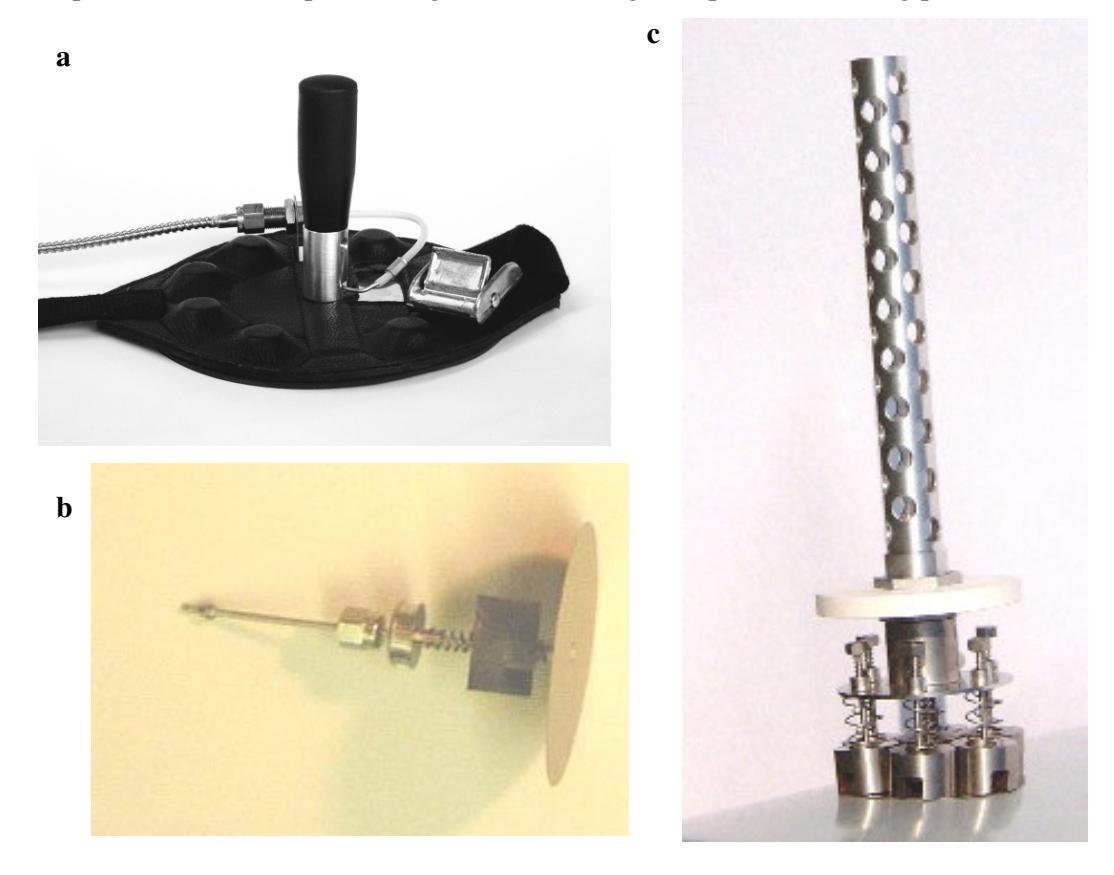
Figure 4, a low temperature roaming probe b, high temperature probe plate, incorporated under heat-pads during bake out. c, high temperature roaming probe.

Throughout this work an intrinsically safe hydrogen collection tool <sup>(2)</sup> was used to obtain efflux data<sup>3-11</sup>. In brief, a collector probe, **Figure 4**, comprising a flexible steel plate 'collector' is attached by straps, banding or magnetically to a steel surface of variable curvature. The underside of the collector had a raised spiral ridge and central capillary such that air drawn into the capillary was first caused to sweep over the steel surface, entraining any emanating hydrogen. From the capillary the air stream is drawn though a flexible capillary, across the sensing face of a detector, and thence to a low voltage, pneumatic pump. The detector current is amplified and displayed or stored. The measurements provided by the hydrogen collection tool are described in more detail elsewhere<sup>3-7</sup>. For low temperature (<150 °C, 300 °F) steel surfaces, a 140 mm diameter probe illustrated in **Figure 4a** was used. The low temperature probe was manipulated with the central handle and the magnets sewn into a leather 'collector bracket'. The probe also contained a strap to facilitate attachment to piping of diameter < 8". This probe was used to measure flux following the discovery of hydrogen damage, and immediately before the bakeout.

During the bakeout, probes tolerating high steel surface temperatures (<450 °C, 840 °F) of 57 mm diameter, shown in **Figure 4b**, were positioned under the lips of adjacent heatpads as shown schematically in **Figure 5**. A roaming high temperature probe, **Figure 4c** was used once during the bakeout to obtain flux readings from the cutaway perimeter interior face. Extensive readings from the vessel underside were limited for safety reasons. Flux readings were obtained from probes either by continuous monitoring and by sequential 60 s 'spot' measurements of hydrogen flux. Throughout the evaluation the prevailing hydrogen background in air was routinely monitored, and found to remain less that 50 pl/cm<sup>2</sup>/s equivalent.

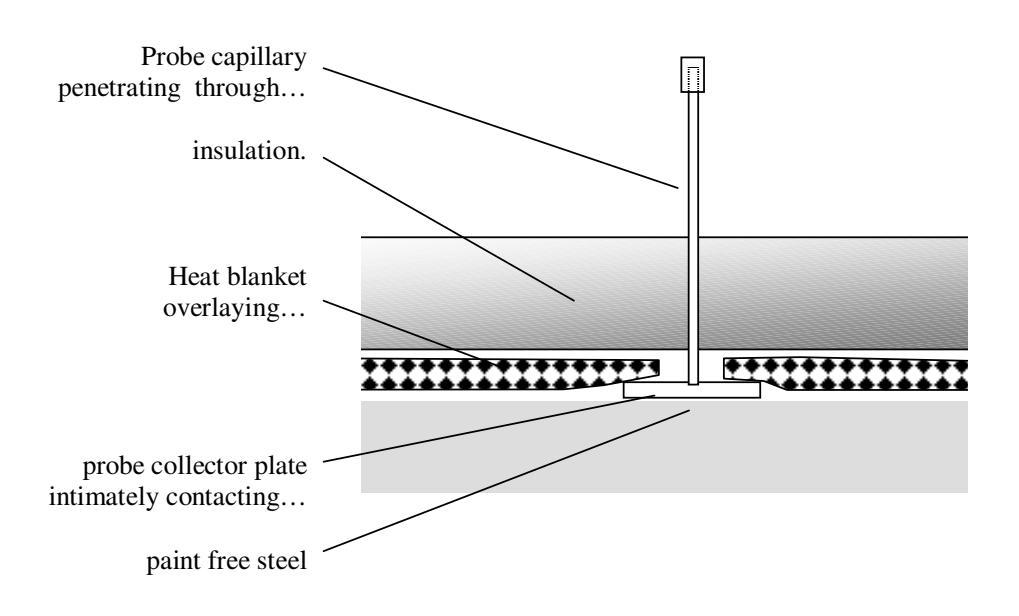
#### Figure 5. Schematic showing hydrogen temperature collector location under heat-pads in cross section.

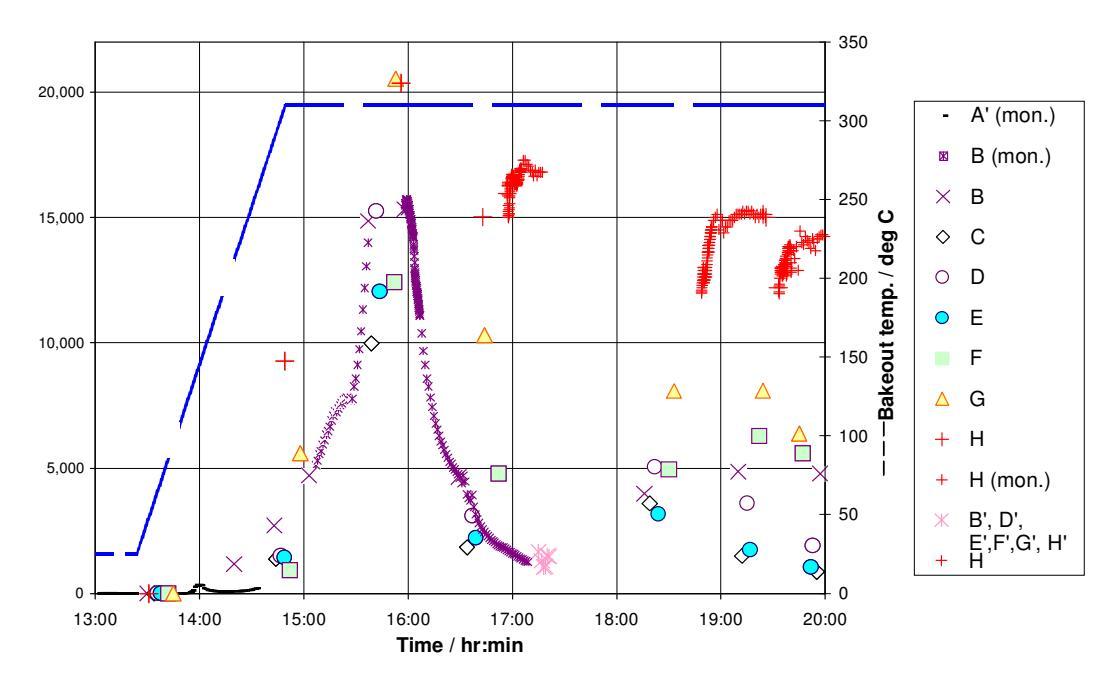
**Figure 6.** All flux measurements carried out in the field, during the period of bake-out, at sites identified in **Figure 4b**, together with the exterior, heated surface cycle temperature (continuous line). Symbols annotated 'Mon.' correspond to continuously monitored, as opposed to spot measurement data.

The flux readings of the bake-out itself are illustrated in **Figure 6**. Immediately striking is the magnitude of flux registered, particularly given that it had been out of service for at least 12 months. By way of comparison, three equidistal circumferential sites located at a vertical mid-section of a 3 m column were fitted with probes exactly as described above. An identical bake-out temperature cycle was used on the 50 mm steel, previously subject 70 °C high pressure hydrogen service. The results are shown in **Figure 7**, indicating maximum flux of 150 pl/cm<sup>2</sup>/s, less than 1% of corresponding values obtained from the acid storage vessel bakeout. For further comparison, a survey of typical 40 mm steel plate exiting a steel plate mill at 300 °C rarely exhibited flux >1000 pl.cm<sup>-2</sup>.s<sup>-1</sup>.

Figure 6 shows that the ranking of site B to H spot measurements by flux magnitude at any one time scarcely changed throughout the bake-out. Thus, any single spot measurement, secured some time after maximum steel temperature was attained,

Several flux profiles shown in **Figure 6** show striking peaks which invite attempts to explain the profiles in terms of a model, which could be further used predictively in future bake-outs of this type. Before presenting our initial investigations in this area it is worth stating that the rate of escape of hydrogen from a steel surface *is* the hydrogen flux J, and equation (i) from which **Figure 8** was obtained, presents a powerful first line of approach in the field for determining the concentration of hydrogen emanating from steel, and concentration liable to remain.

Most sites show a slight dip in hydrogen concentration at 16:00 hr, which is difficult to attribute to the model. One of the model's limitations is the invocation of uniform diffuse flat traps in any plane parallel to a efflux surfaces. The diffusion coefficient – even at 300  $^{\circ}$ C – pertaining to any plane of deep and dense hydrogen traps will be unavoidably so low as to prevent hydrogen from substantially traversing it. A model in which hydrogen

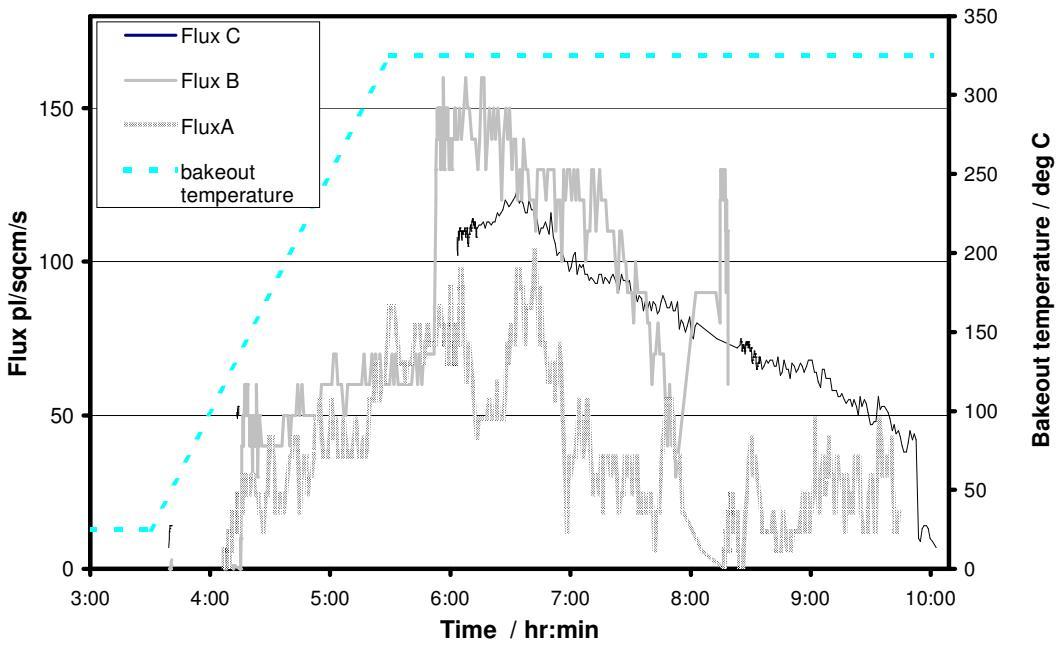
**Figure 7.** Flux measurements carried out in a column bakeout . The steel was of identical thickness, subject the same temperature cycling regime as the acid storage vessel dome bake-out featured in this work. The flux measurement approaches the detection limit of the HT collector used on sites A and B. The larger LT collector was used at site C; note the finer resolution. Gaps in data occurred at times of using probes to survey nearby equipment, where, as below, flux was less than 1% of typical flux values obtained from the vessel dome bake-out.

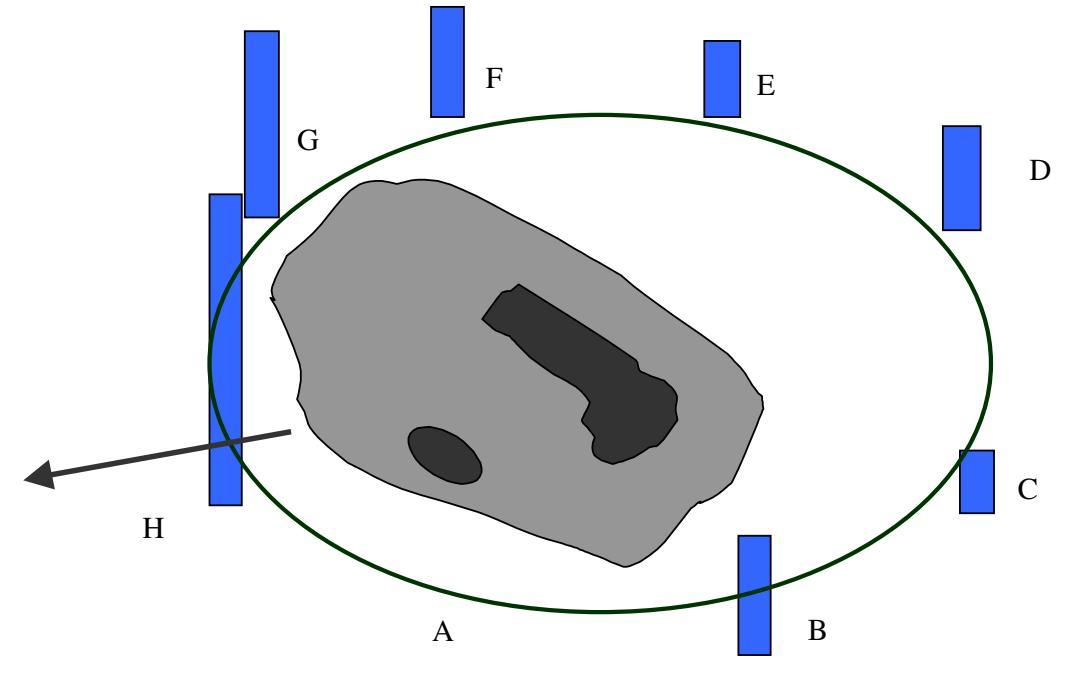
**Figure 8** illustrating the relative total volumes of hydrogen emanating from the steel at the monitored test sites on the dome exterior surface during the initial bake-out, expressed as ppm (H in steel by wt) x depth (cm). Site H delivered 0.40 ppm.cm. The arrow indicates the direction of lamination growth prior to removal from active service.

From equation (i) we obtain maximum total hydrogen out-gassed at respective bakeout sites, illustrated in **Figure 8**, expressed as  $c.\mathbf{x}$ ; the average hydrogen in steel concentration released, c (ppm), to a depth of steel,  $\mathbf{x}$  (cm). Whilst these levels may appear modest, it should be recalled that equation (i) assumes all hydrogen escape is directed normal to the steel surface. Since the diffusion parallel to the steel surface is enhanced with respect to normal diffusion (due to elongation of grains parallel to the surface during plate manufacture and therefore less intergranular hydrogen migrations per unit distance in this direction) the estimates are low: substantive hydrogen could be expected to diffuse towards and efflux from the cut-away perimeter. The high and slowly decaying efflux from sites G and H therefore led us to conclude that a further bakeout at 310 °C was warranted, and on the day following the work carried out by site staff. Initially, zero flux was reported at site H. On reaching 320 °C, the flux returned to its final value shown in **Figure 6**, namely 13,000 pl.cm<sup>-2</sup>.s<sup>-1</sup> after 4 hr. At this point the bakeout was deemed complete.

The high concentrations of hydrogen collected from sites G and H corresponds to those sites being closest to the areas of lamination and blistering in the steel cut away, as indicated in **Figure 8**. Perhaps even more significant, this is precisely the direction in which the field of hydrogen lamination had been growing, **Figure 2**, whereas extensive USTM and TOFD scanning failed to identify damage outside the cutaway perimeter . On the evidence of this we are convinced that, presented with high hydrogen activities, substantial densities of hydrogen traps are generated in steel, wherein permanent hydrogen uptake occurs, prior to their development into detectable laminations and blisters.

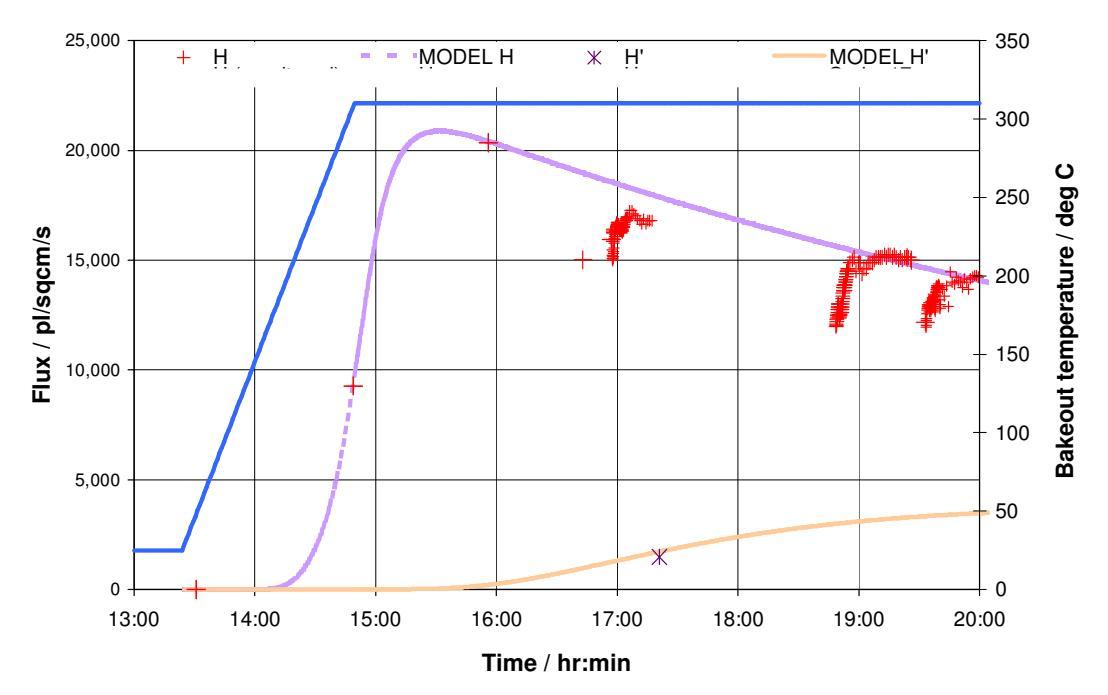
The flux output from both the exterior and interior faces according to the values quoted in **Table 1** for site H is shown in **Figure 9**. Other peaks in **Figure 6** can be well modelled, again, by appealing to a 'hotspot' of an increased density of moderately deep traps within the 5 to 15 mm of the exterior face of the baked out dome. This is exactly where TOFD revealed laminations in nearby cut-away steel. The model therefore supports our conclusion above, that prior to detectable lamination, substantial hydrogen uptake can occur within a specific steel zone.

**Table 1**. One-sided bakeout model. Notes: *1*, parameters estimated or defined by the actual bake-out; *2*, values derived from literature values , notably Grabke and Riecke<sup>12</sup>, who developed the flat trap model of McNabb and Foster<sup>13</sup>, on which the bakeout model was based; *3*, values optimised within sensible limits to obtain close fit with real efflux profile of site H, reproduced in **Figure 9**.
